**FUJITSU GENERAL AMERICA, INC**

**SERVICE BULLETIN**

Number: 0009

Poor connections of wire harness in the EEV cover.

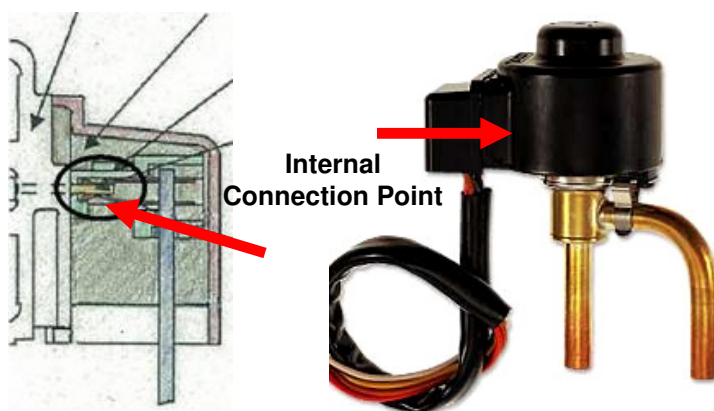
The mixture of epoxy and stiffening materials in the EEV cover, which fix the connector and wires at the FUJIKOUKI Electronic Expansion Valve, did not have the correct mix ratio. Because the ratio was incorrect, depending on the temperature, the wires would separate internally from the coil preventing the EEV from opening or closing.

The models affected have serial numbers below the ones on this table and should be replaced. Contact your local distributor to order the EEV.
