**ENERGY APPORTIONMENT TOUCH PANEL CONTROLLER UTY- DTGYZ1
SOFTWARE UPDATE L002****Source for this Bulletin**

Japan Service Bulletin VRF-0144 issued August 22, 2016

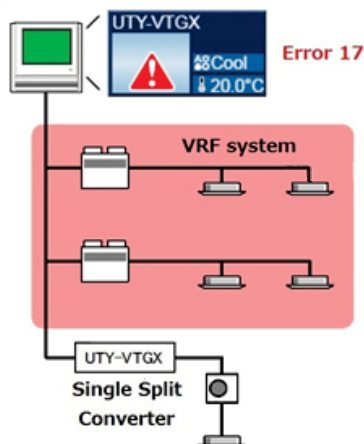
Touch Panel Controller (TPC) may produce Error E17 that is due to the following combined conditions:

1. Electricity Charge Apportionment (UTY-PTGXA) is installed.
2. A Single Split System Converter is connected to the same VRF network.

**Example of Error 17 occur when using a single split system on VRF Network.**

Error should not be displayed, because the Electricity Charge Apportionment (ECA) function is not available for single split systems.

1. Download the file "gktkp_010002.rpm" from the Fujitsu Portal >> Downloads >> Touch Panel Controller with Internet Optional Software >>Energy Apportionment SOFTWARE UPDATE L002
2. Copy the file to a USB memory stick.
3. Plug the USB memory stick into the TPC while it is powered ON.
4. The update to the TPC will start automatically.
