ELECTRIC FURNACES; VENTILATION STARTS TO OPERATE NON-STOP

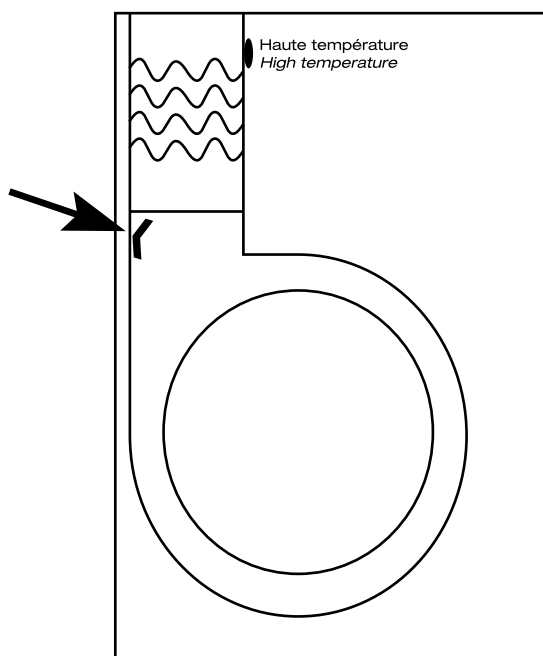
The problem occurs most often when replacing oil furnaces because the ducts are larger than those required for connecting an electric furnace: therefore some turbulence at the air output prevents the air from cooling near the high temperature control.

The problem may be resolved and turbulence avoided by simply installing a deflector in the ventilator.
