FUJITSU GENERAL AMERICA, INC 353 Route West. Fairfield, NJ 07004 Ph: 973-575-0381 Fx: 973-836-0449 Em: ServiceHVAC@fujitsugeneral.com	SERVICE BULLETIN Number: 0025 Date: 12/3/2012 TYPE: Field

MODEL : **ASU- 9-12-15RLS2**	PART NUMBER: **KCLIPRLS2**

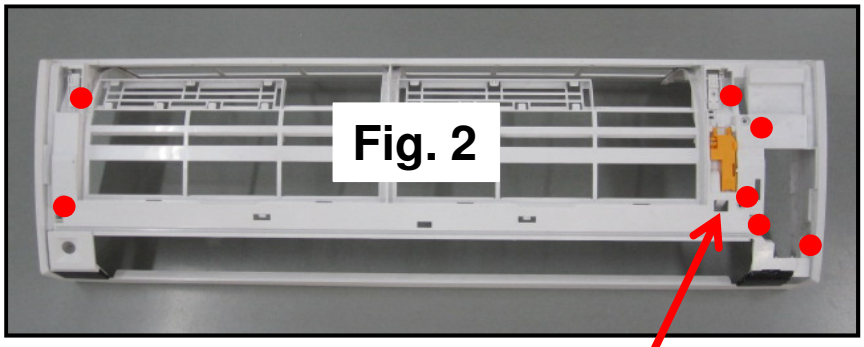
Fig. 2

2. The **red** circles indicate the screws that need to be removed to dismount the evaporator cover.

3. Remove the front panel cover screws. Proceed to remove entire cover from evaporator.

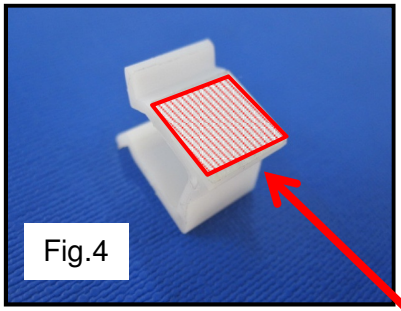
PROBLEM:	**Evaporator intake grille may not completely close.**
SOLUTION:	Add an adhesive tape to make intake grille clip fit tighter making sure panel snaps completely closed.

Attach the adhesive modification sheet in (fig 4) to either side of the clip.
