RefPlus® recommends the inspection of all axial fan motors installed on unit models starting with the following first two letters:

12 MONTH LIMITED WARRANTY EXTENSION ON SERVICED FAN UNITS

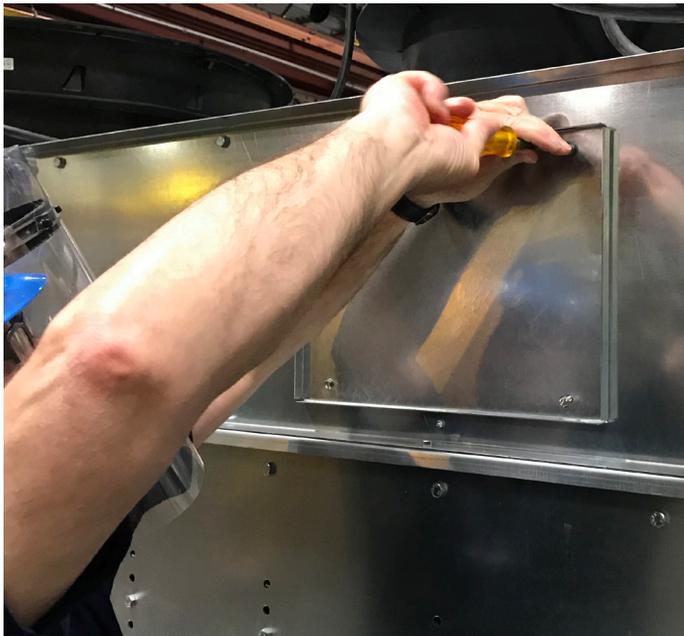
On these models, the drain plug is accessible through small doors located on each side of the unit.

1. Remove the door panel by removing the 4 bolts.

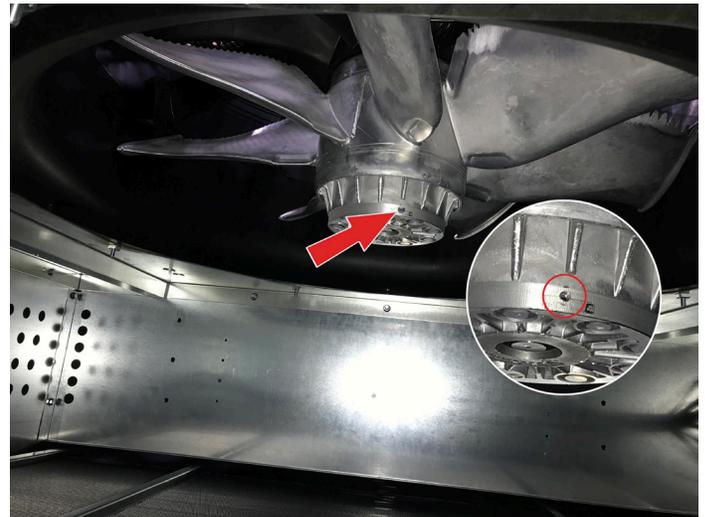
We were recently advised by Ziehl-Abegg that the axial fan(s) installed on the above listed models may be fitted with a drain plug and that this plug, if existent, must be removed to allow proper water drainage.

2. Once the panel removed, you will have access to the fan hub, as shown. On the hub, you will find a small screw that acts as a plug. Use a TX-20 screwdriver to permanently remove this screw.

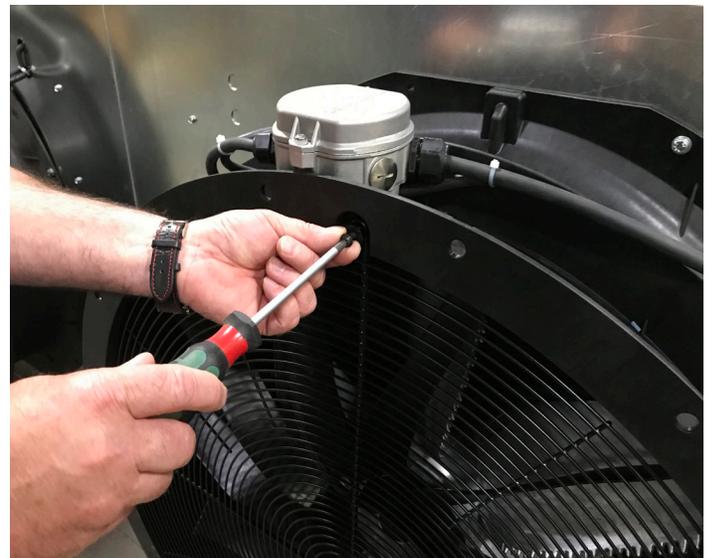
On these particular models, the plug is accessible from the top of the unit.

1. Remove the fan guard by first removing the 4 bolts with a TX-30 screwdriver.
